Coal Mine Fatal Accident 2006-47

Operator:	Dana Mining Company Inc
Mine:	Prime No 1
Accident Date:	December 17, 2006
Classification:	Fall of Roof or Back
Location:	Dist. 3, Monongalia County, West Virginia
Mine Type:	Underground Coal Mine
Employment:	63
Production:	4,000 Tons/Day

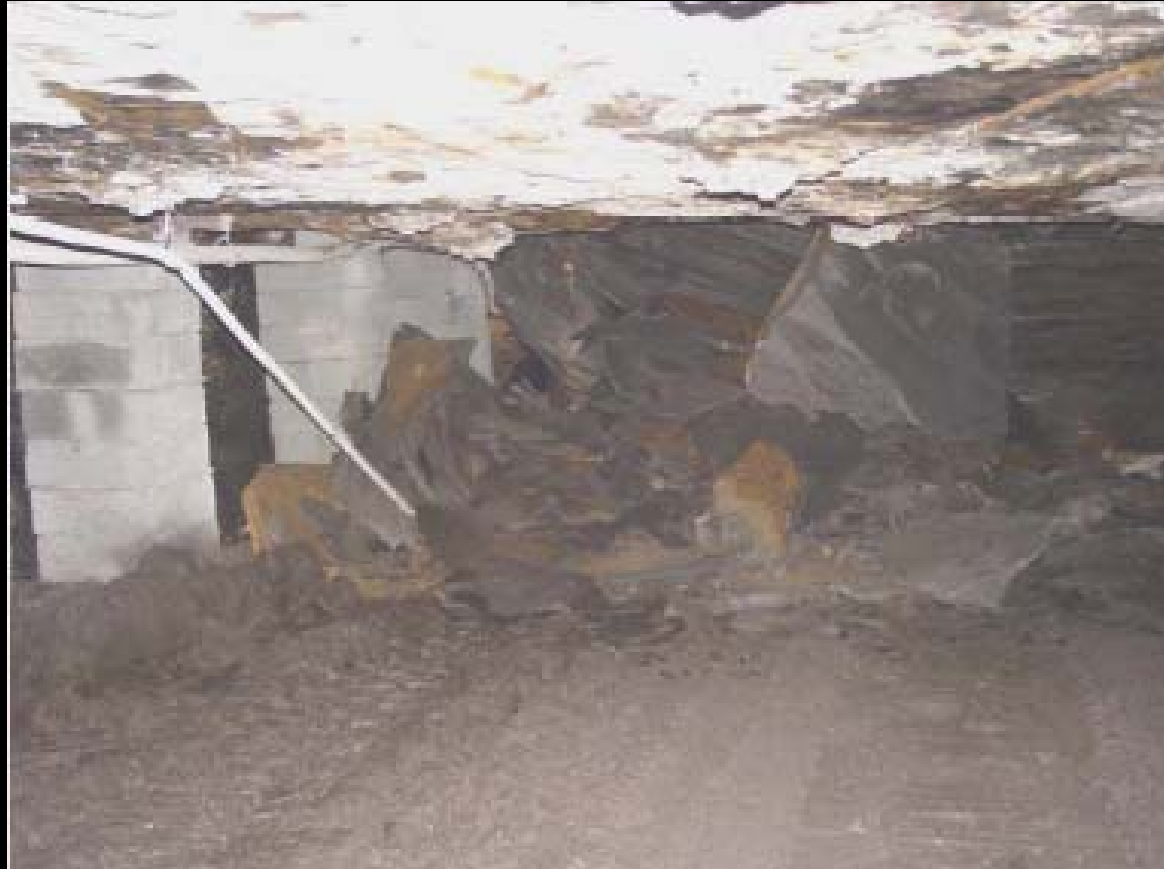
On December 17, 2006 at approximately 7:30 p.m. a 26-year old mechanic was fatally injured in a roof fall. The victim and 2 co-workers were traveling through the No. 18 block intersection (No. 2 entry) on a rubber tire personnel carrier when the top began to work and fall. The fall was approximately 28

feet long, 20 feet wide and 5.5 feet thick. The roof fall appears to have resulted from several geological conditions present in the No. 18 crosscut area of the mains. First, ground water inflow over time weakened the rock in the immediate roof susceptible to moisture. The roof fall appears to have started on the inby side of the intersection where moisture had caused weathering or weakening of the immediate roof and progressed along a vertical fracture that cut through the intersection, parallel with the entry.

Corrective Action: Examiners and miners were provided additional training in the recognition of adverse geologic conditions. The approved roof control plan was updated to supplement roof support in the regularly traveled haul road intersections from the No. 1 belt head to the No. 2 belt tail piece. Supplemental support consists of a minimum six cable bolts, 8-14 feet and 6 foot fully grouted roof bolts will be installed with 18 inch by 18 inch roof mats. The provision of supplemental support also was extended to all regularly traveled haul road intersections in the travel entry where adverse geologic conditions are recognized.
